PROCEEDINGS OF INTERNATIONAL CONFERENCE ON ISTANBUL AND EARTHQUAKE 2022

Organized by IAU Disaster Training Application and Research Center (AFAM)

**PROCEEDINGS OF INTERNATIONAL CONFERENCE
ON ISTANBUL AND EARTHQUAKE 2022**

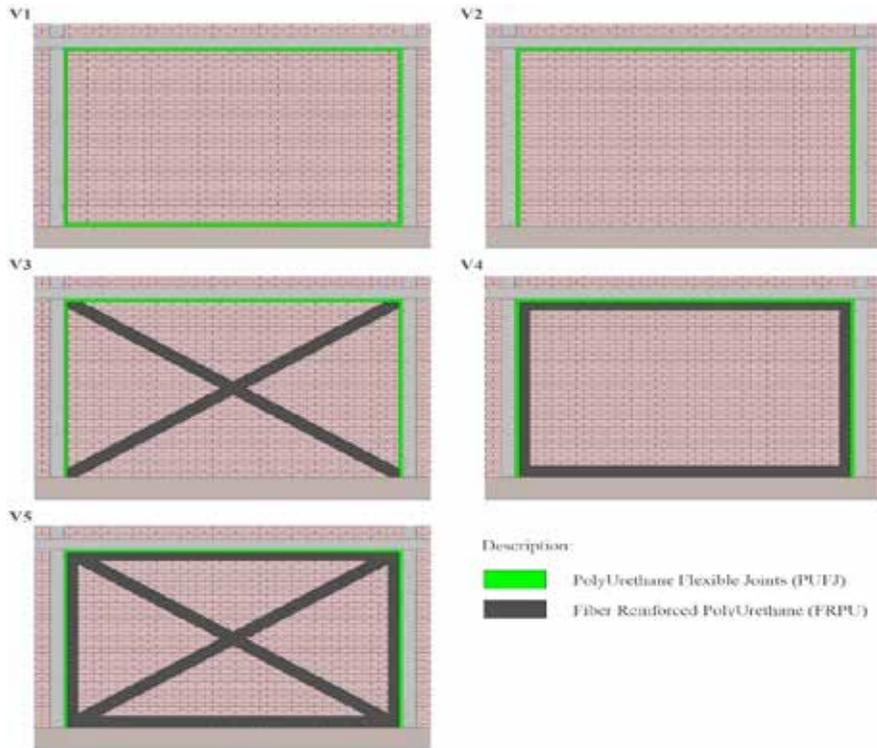
Figure 1. Innovative anti-seismic protection systems: V1 – prefabricated PUFJ at 4 interfaces; V2 – injected PUFJ at 3 interfaces without application of FRPU; V3 – injected PUFJ at 3 interfaces and application of FRPU at infill diagonals; V4 – injected PUFJ at 3 interfaces and application of FRPU at infill edges; V5 – injected PUFJ at 3 interfaces and application of FRPU at infill diagonals and edges both.

All variants are shown in Figure 1.

To calculate the value of the life cycle costs for all variants (V1-V5) of the innovative anti-seismic protection systems, application presented in Figure 1 and the variant corresponding to the reference scenario (V0), the Net Present Value (NPV) method recommended by ISO 15686-5:2017 (ISO, 2017), was applied. According to the method, the net present value (NPV) may be described as the sum of the discounted benefit of a given variant of the investment project (or construction system implementation) less the sum of the discounted costs. In the case of where costs only are taken into account, the NPV may be called the net present cost (NPC). The NPV or NPC is calculated using the following formula:

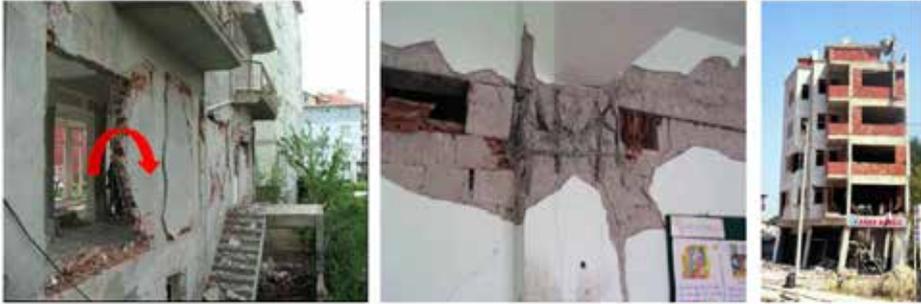
Figure 1. Infill wall related failures after earthquakes; in-plane and out-of-plane damages (left) [3], corner crushing of the wall and shear damage on column (middle) [4], and soft-story mechanism (right) [5].

limited to in-plane and out-of-plane damages, soft-story effects and short-column shear damages on columns, see Figure 1 [3-5].

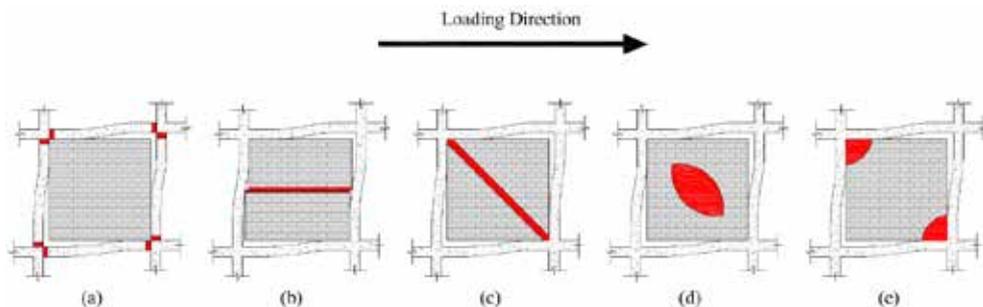
Figure 2. Common infill wall related failure mechanisms; (a) frame damage, (b) horizontal shear, (c) diagonal crack, (d) mid-height diagonal compression, (e) corner crushing.

strong bricks are preferred in the wall. In Figure 2, typical infilled system damages are illustrated.

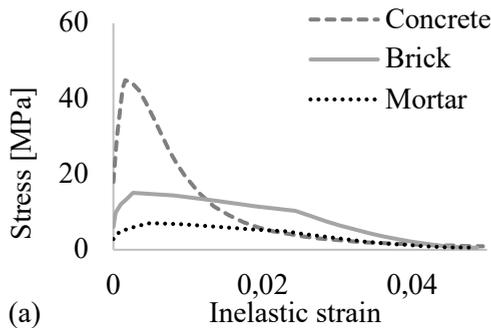
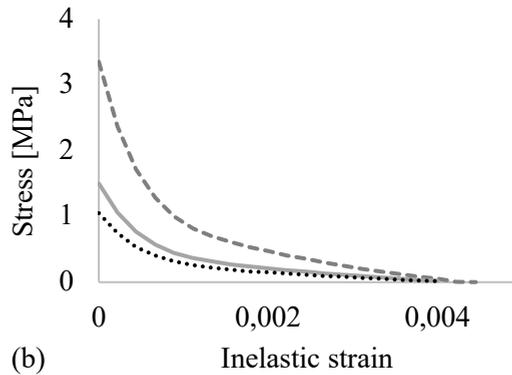
Figure 4. Concrete, brick and mortar mechanical properties; (a) compressive, (b) tensile.

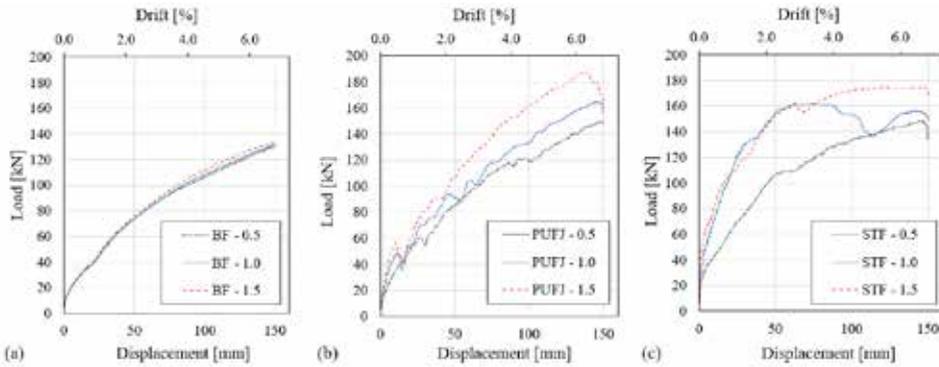
Figure 6. Load – displacement curves of the frames based on the aspect ratio variations; (a) BF, (b) PUFJ and (c) STF.

For the case of load capacities; peak values of the curves were considered for identifying the maximum load levels. In addition, initial stiffness values of the frames were determined by calculating the slopes of tangent lines correspond to the 10% of maximum load values of those curves [21]. Secant stiffness values were also determined in a similar way; yet this time, the loads at the ultimate horizontal displacements were utilized. These curves are presented in Figures 6-7.

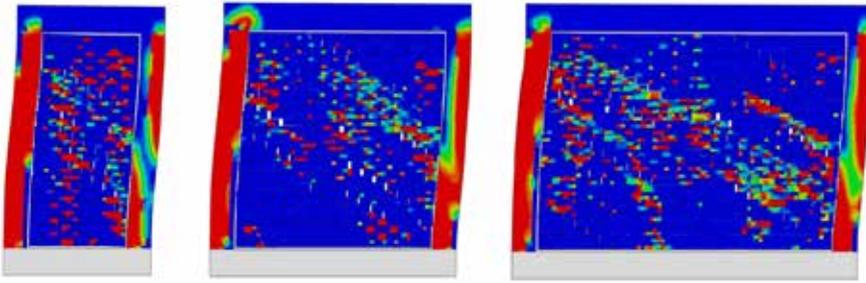
Figure 8. Cracking damage status of the PUFJ frames at the end of analyses; aspect ratio: 0.5 (left), aspect ratio: 1.0 (middle) and aspect ratio: 1.5 (right).

strut shape for the aspect ratio of 1.0, and an irregular mix of sliding-shear and diagonal compression could be stated as the failure of the frame with the aspect ratio of 1.5. It is also worth to mention that the connection loss between the frame and wall was encountered in these frames as a result of the implementation of stiff joints which were not able to resist the larger displacement demands and could not distribute the stresses. Moreover, in both PUFJ and STF frames, the columns were severely damaged due to the plastic hinges occurred starting the column ends, and later spreading along these vertical members, though the beams were in good condition at the end of analyses. These damages are presented in Figures 8-9.

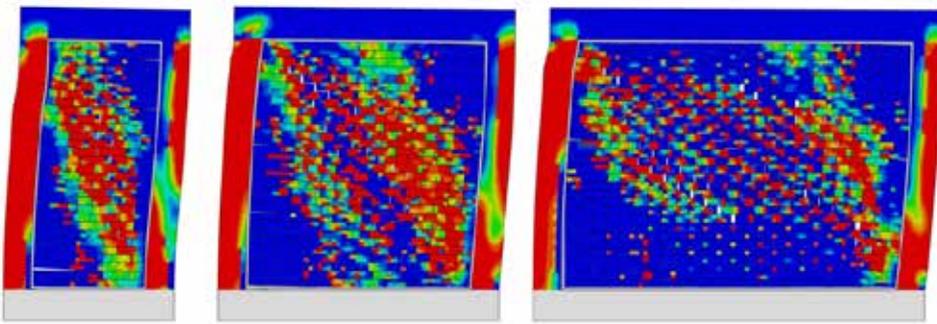
Figure 9. Cracking damage status of the STF frames at the end of analyses; aspect ratio: 0.5 (left), aspect ratio: 1.0 (middle) and aspect ratio: 1.5 (right).

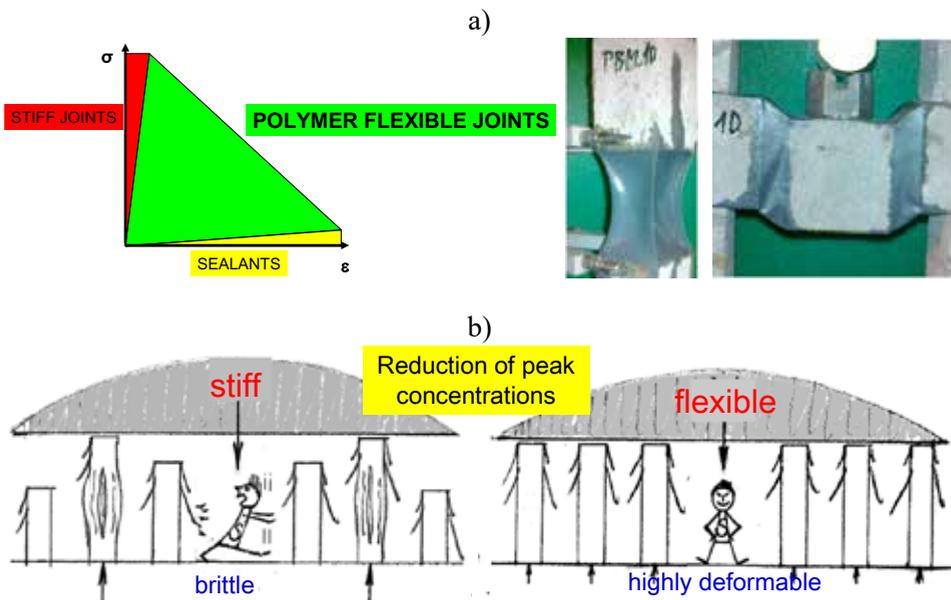
Figure 1. Polymer Flexible Joints (PFJ) transferring loads and large deformations simultaneously (a), schematically presented idea of reduction of stress concentrations and even redistribution of stress by highly deformable flexible polyurethanes (b).

carry high loads but unable to carry high deformations) and sealants (capable to carry high deformations but unable to carry high loads). The gap between them was empty in the case of construction industry, whereas in motor and marine industries this gap was fulfilled by flexible connectors. Following those branches, a new sort of structural joints was introduced in construction industry, named Polymer Flexible Joints – PFJ (Fig. 1a). They are capable to carry high loads and large deformations simultaneously. They also allow for reducing of stress concentrations and redistributing them over large bonding area (Fig. 1b).

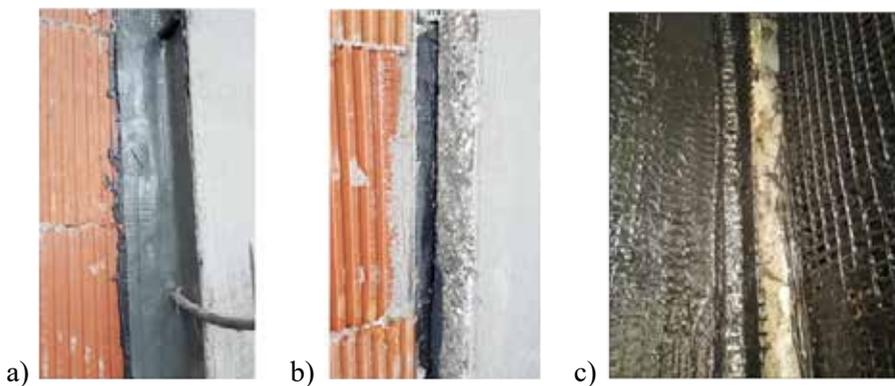
Figure 2. Injected PUFJ (a), prefabricated PUFJ (b) and FRPU composite (c).

Prefabricated PUFJ (Fig. 2b) is a flexible layer constructed on site or in a factory, which connects structural and non-structural elements with special adhesives and can be adjusted to any bonding surface shapes and thicknesses. It can be installed on all RC frame elements' surfaces and then the space can be filled with masonry (Fig. 3a). It is dedicated for seismic improvement of existing RC frame structures (new or old after an earthquake), before an infill installation.

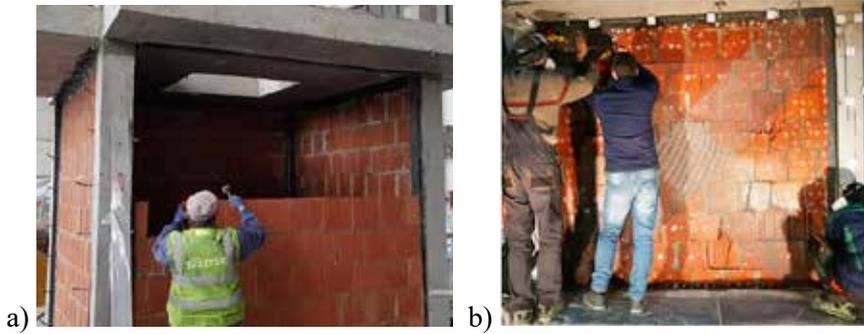
Figure 3. Installation of: injected and prefabricated PUFJ (a), FRPU composite (b).

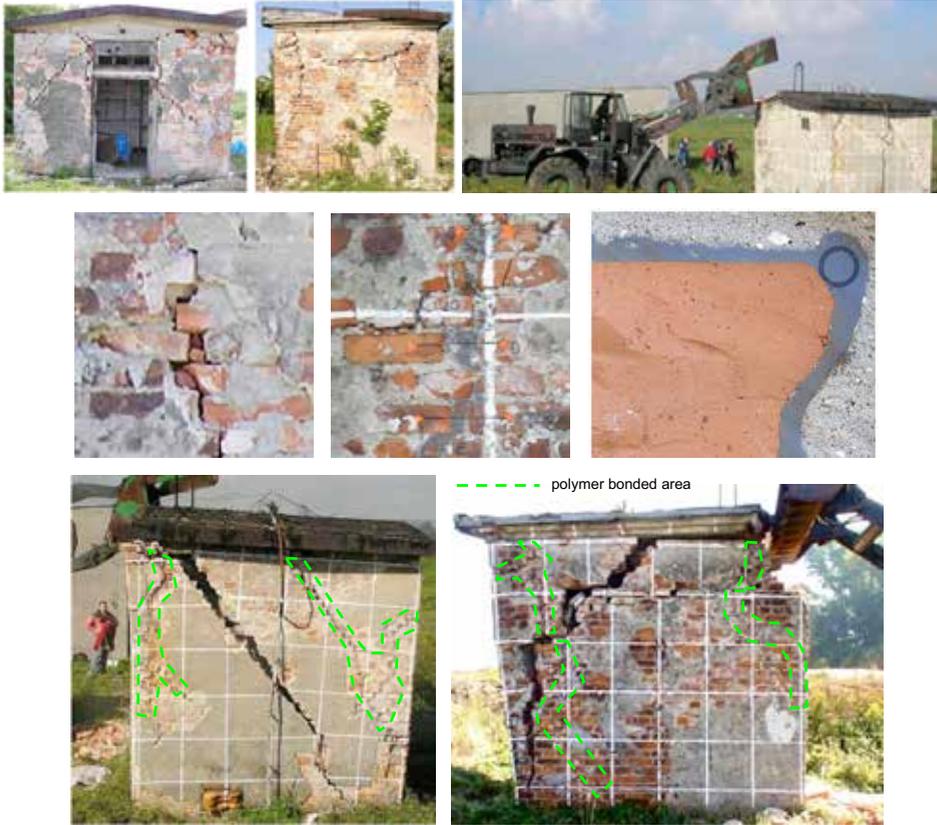
Figure 4. Seriously cracked masonry building repaired by injected PUFJ and efficiently protected against dynamic loading caused by a caterpillar [6].

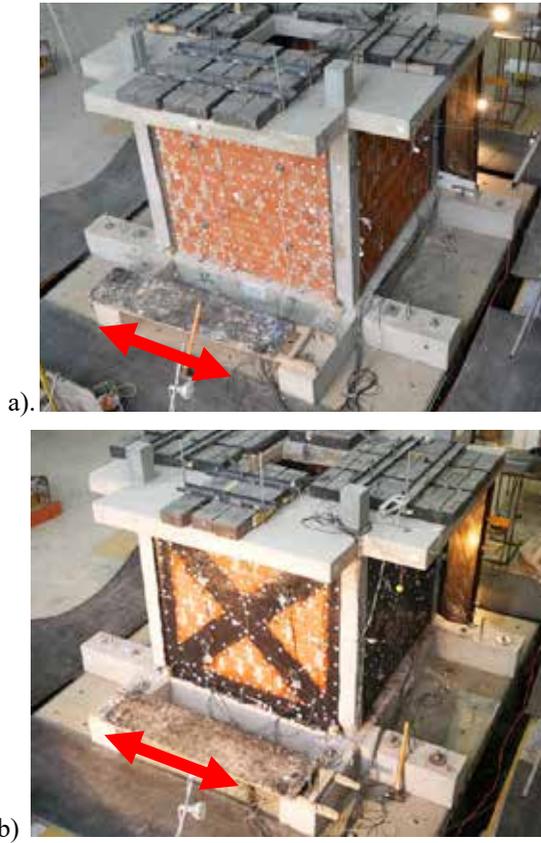
Figure 5. View of the RC building with infill walls protected by PUFJ and FRPU on the shake table in IZIIS: PHASE 1 - B (in-plane) and C (out-of-plane) (a), PHASE 4 - B_FRPU (out-of-plane) and C_FRPU (in-plane) (b).

In PHASE 1 (10 gradually increasing seismic excitations up to 77%KEF), the infill walls of type B were tested in-plane and the infill walls of type C were tested out-of-plane. In PHASE 2 (3 gradually increasing seismic excitations up to 18%KEF), the heavily damaged B-type walls (Fig. 6a) were reinforced with FRPU on both sides (B_FRPU – Fig. 6b) and the 3D specimen was excited again, but to a level that was safe for the building specimen. After rotating the building by 90 degrees, the type C walls were tested in-plane until the moment when bonds in the mortar joints between the wall blocks were opened (Fig. 6c) - PHASE 3 (3 gradually increasing seismic excitations up to 16%KEF). In the same phase, B_FRPU specimens were tested out-of-plane. After the FRPU reinforcement of the type C walls (C_FRPU – Fig. 6d), the tests were continued in PHASE 4 (7 gradually increasing seismic excitations up to 45%KEF) up to the maximum load capacity of the seismic table (limitation caused by the failure of an actuator). Maximum values recorded during the dynamic tests on the shake table in four phases are presented in Table 1.

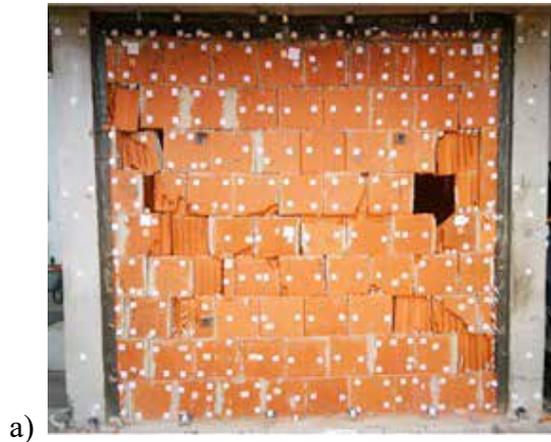
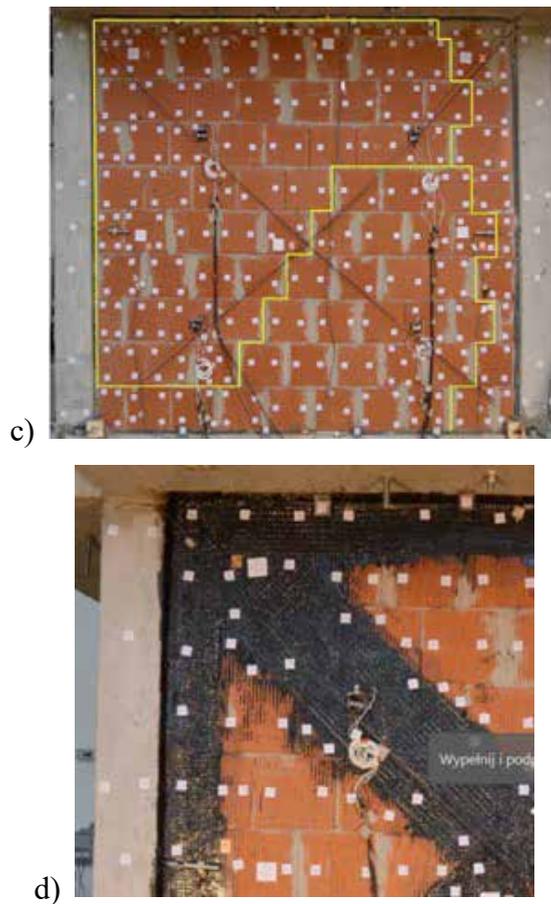
Figure 6. Views of in-plane tested faces of the 3D specimen: in PHASE 1 – seriously damaged infill B (a), in PHASE 2 – damaged infill B protected by FRPU (b), in PHASE 3 –infill C with opened mortar joints (c), in PHASE 4 - cracked infill C protected by FRPU (d).

The presented maximum values indicate that the PUFJ kept a very badly damaged B-type infill in the plane of the frame, even for accelerations above 1.5 g and the building deflection of 3.7%, and the C-type infill withstood the same excitation in out-of-plane mode.

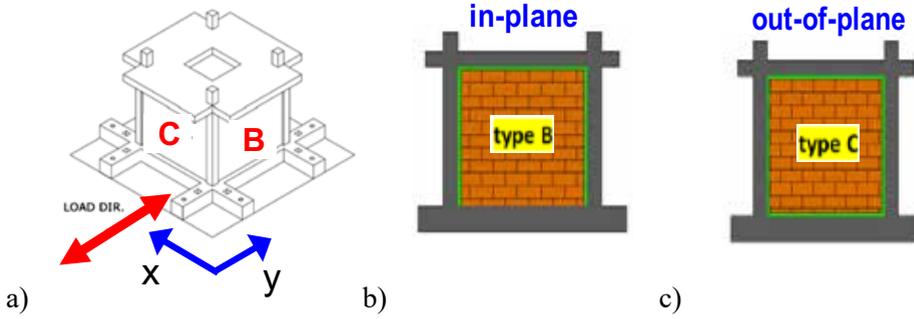
Figure 7. Setup of the full scale specimen on a shake table in PHASE 1: Position of the type B and type C infills in relation to load direction (a); infill type B excited in-plane (b); infill type C excited out-of-plane (c).

Positions in tests of infill walls of type B and C, with FRPU protection or without, in relation to in-plane and out-of-plane modes, are presented in Figures 7bc, 10bc, 13bc and 16bc.

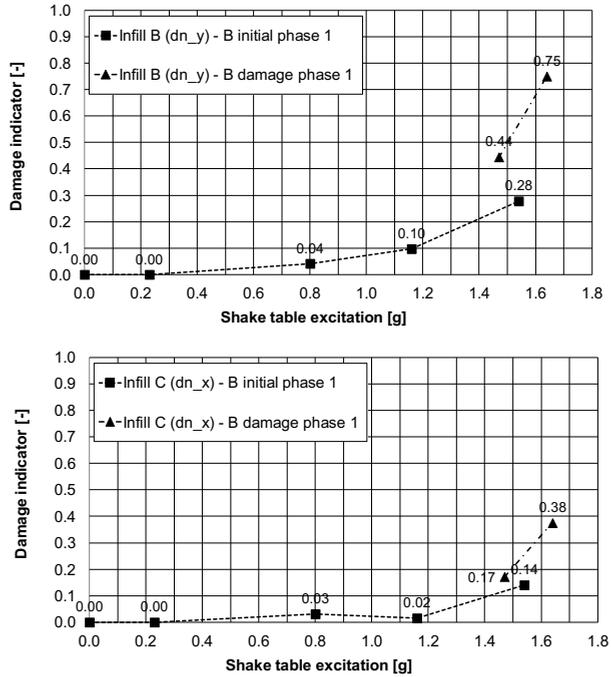
Figure 9. Change of damage indicator of the full scale specimen on a shake table in PHASE 1: d_{nY} - infill type B excited in-plane (left); d_{nX} - infill type C excited out-of-plane (right).

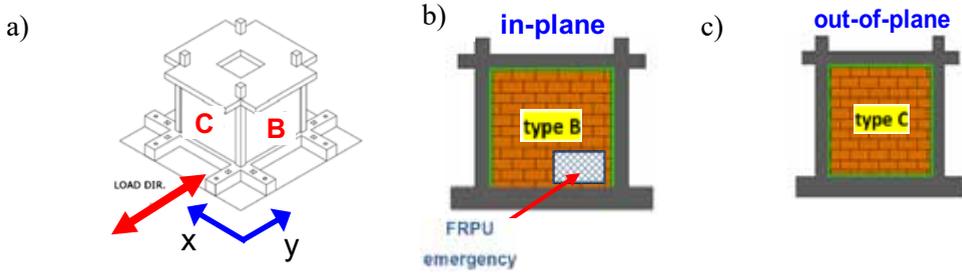
Figure 10. Setup of the full scale specimen on a shake table in PHASE 2: Position of the type B and type C infills in relation to load direction (a); infill type B protected by FRPU excited in-plane (b); infill type C excited out-of-plane (c).

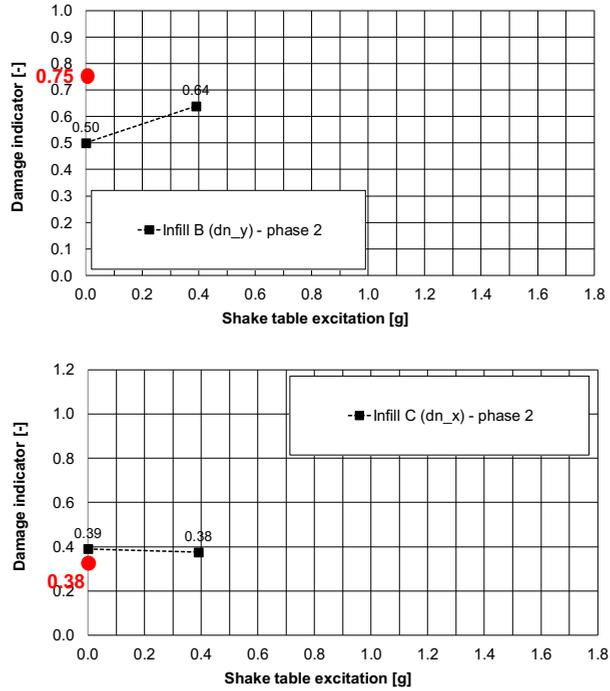
Figure 12. Change of damage indicator of the full scale specimen on a shake table in PHASE 2: d_{nY} - infill type B protected by FRPU excited in-plane (left); d_{nX} - infill type C excited out-of-plane (right). Red dot indicates final damage indicator from previous phase.

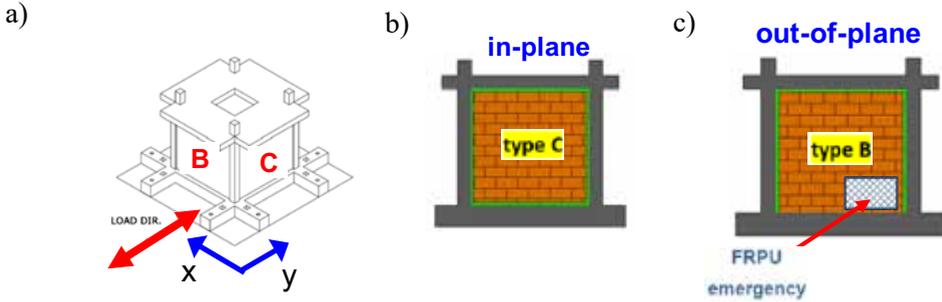
Figure 13. Setup of the full scale specimen on a shake table in PHASE 3: Position of the type B and type C infills in relation to load direction (a); infill type C excited in-plane (b); infill type B protected by FRPU excited out-of-plane (c).

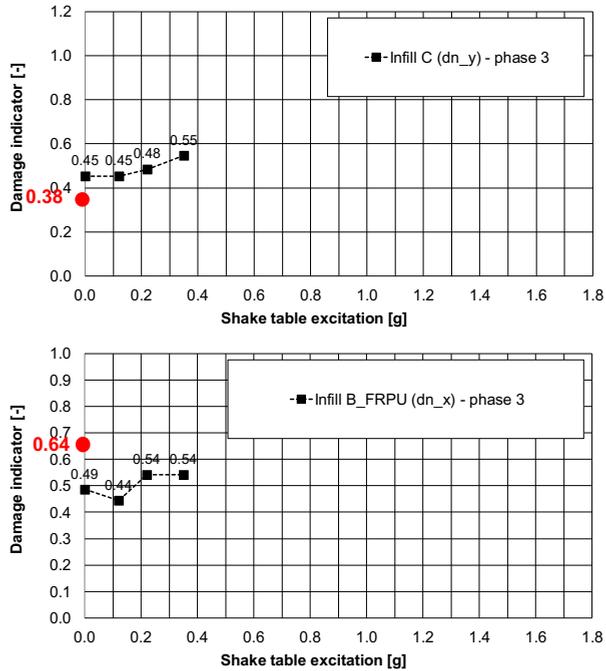
Figure 15. Change of damage indicator of the full scale specimen on a shake table in PHASE 3: d_{nY} - infill type C excited in-plane (left); d_{nX} - infill type B protected by FRPU excited out-of-plane (right). Red dot indicates final damage indicator from previous phase.

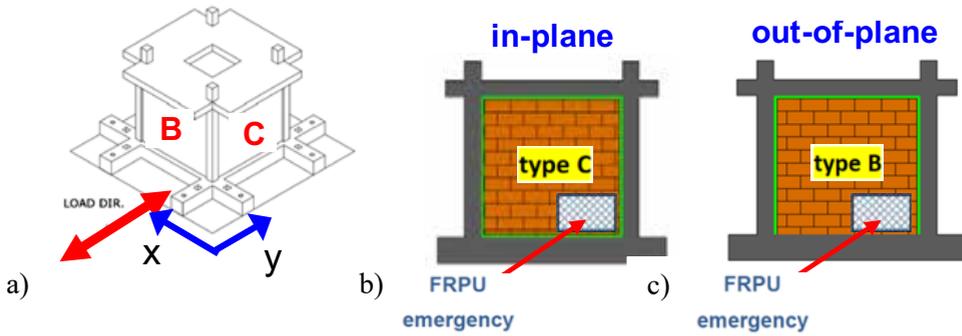
Figure 16. Setup of the full scale specimen on a shake table in PHASE 4: Position of the type B and type C infills in relation to load direction (a); infill type C protected by FRPU excited in-plane (b); infill type B protected by FRPU excited out-of-plane (c).

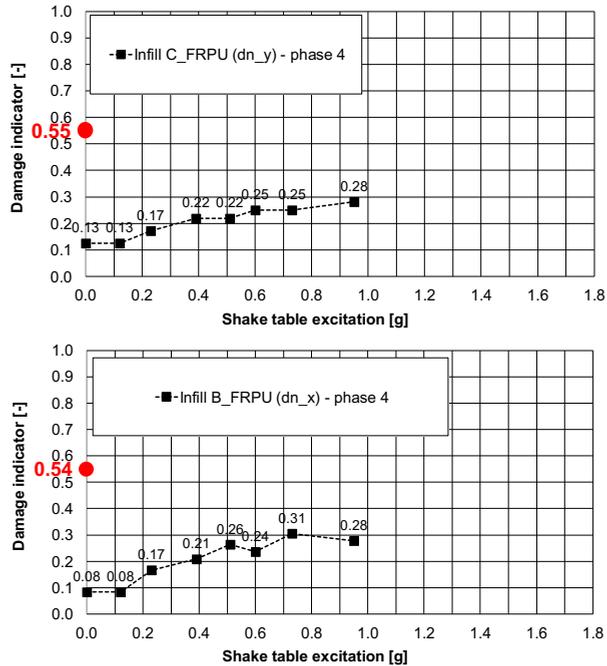
Figure 18. Change of damage indicator of the full scale specimen on a shake table in PHASE 4: d_{nY} - infill type C protected by FRPU excited in-plane (left); d_{nX} - infill type B protected by FRPU excited out-of-plane (right). Red dot indicates final damage indicator from previous phase.

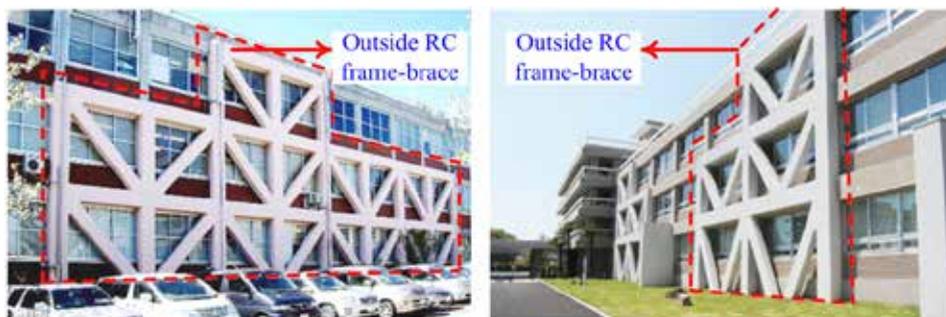
Figure 1. External retrofitting by RC braced frames (Cao et al., 2020)

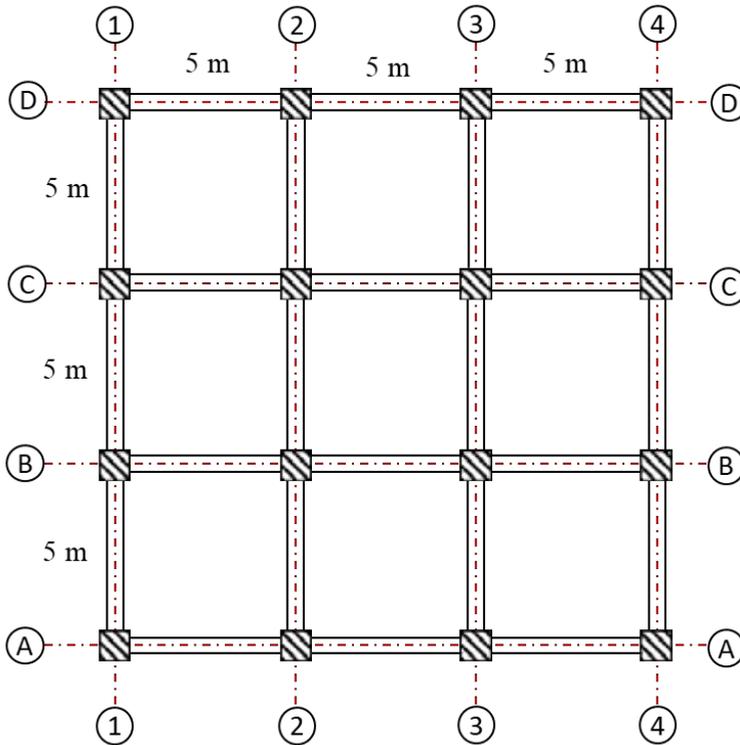
Figure 3. General plan, and beam and columns layout of the considered buildings

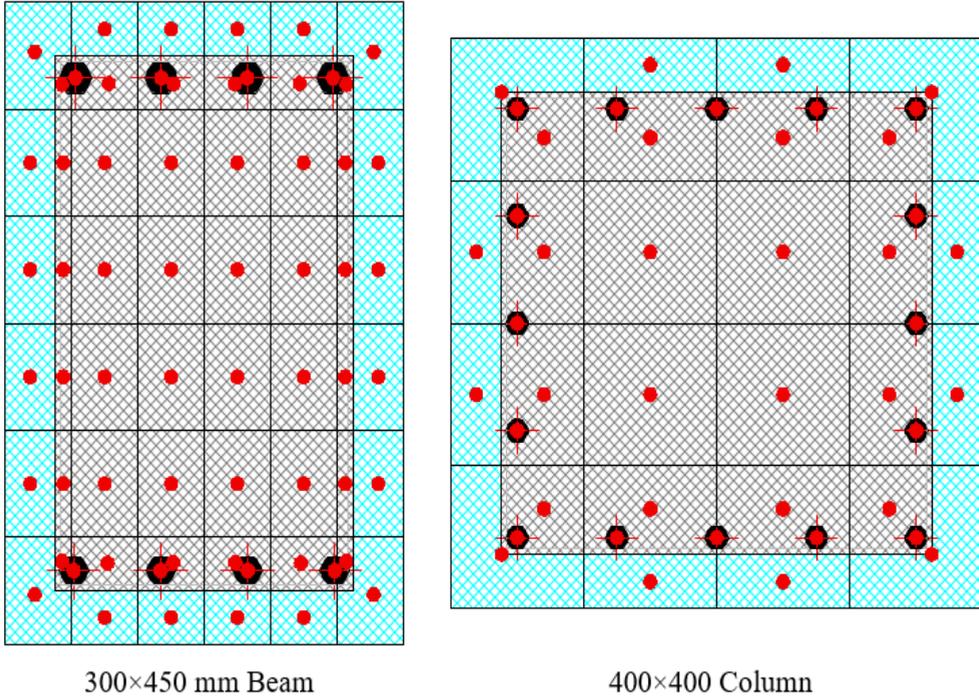
Figure 4. Discretization of fibers in beams and columns of the analyzed buildings

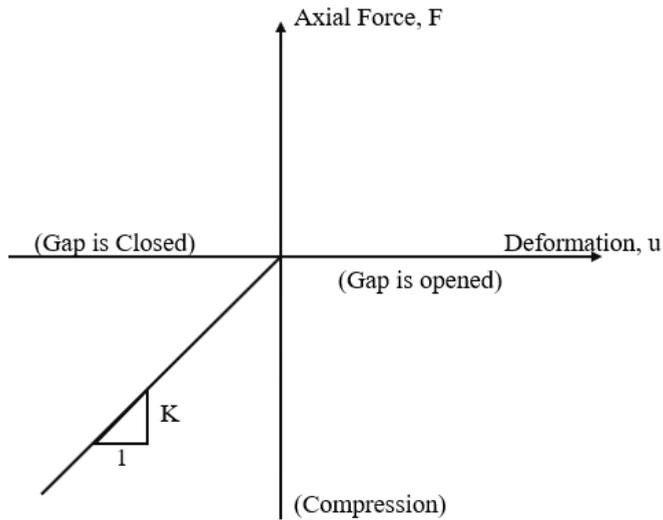
Figure 5. The force-deformation relationship in the gap element

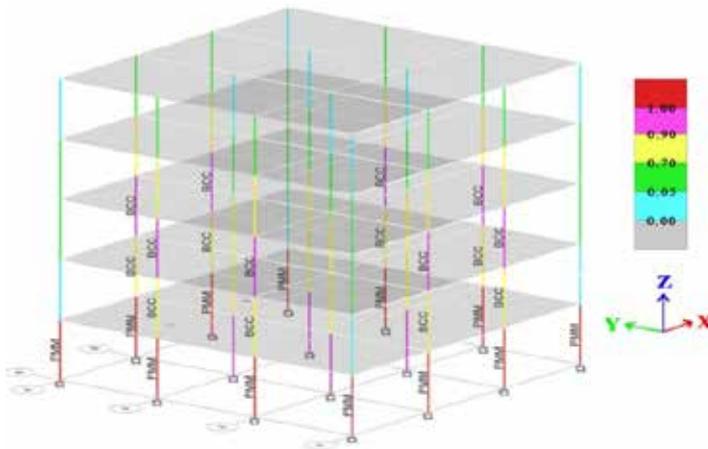
Figure 6. Deficiencies identified by the linear analysis of the 5-story bare structure

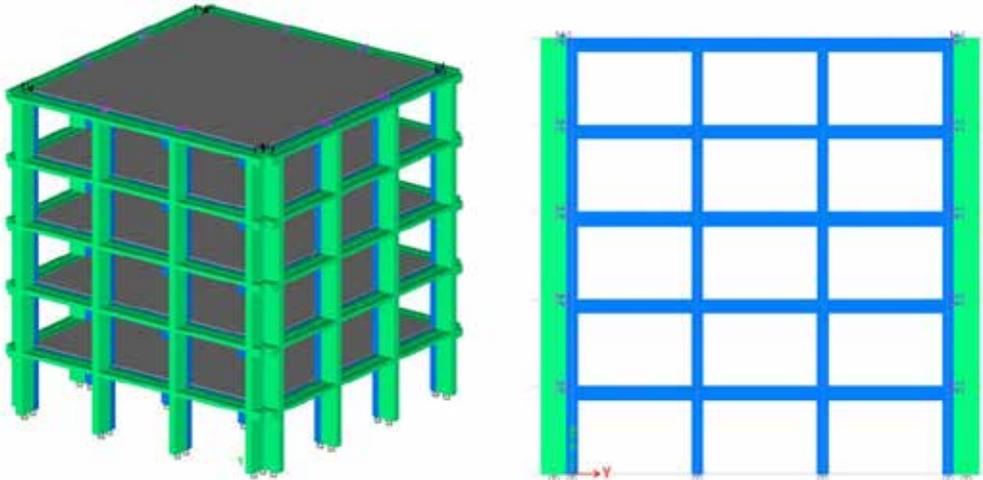
Figure 8. 3D view and section of the retrofitted 5-story building by encasement technique

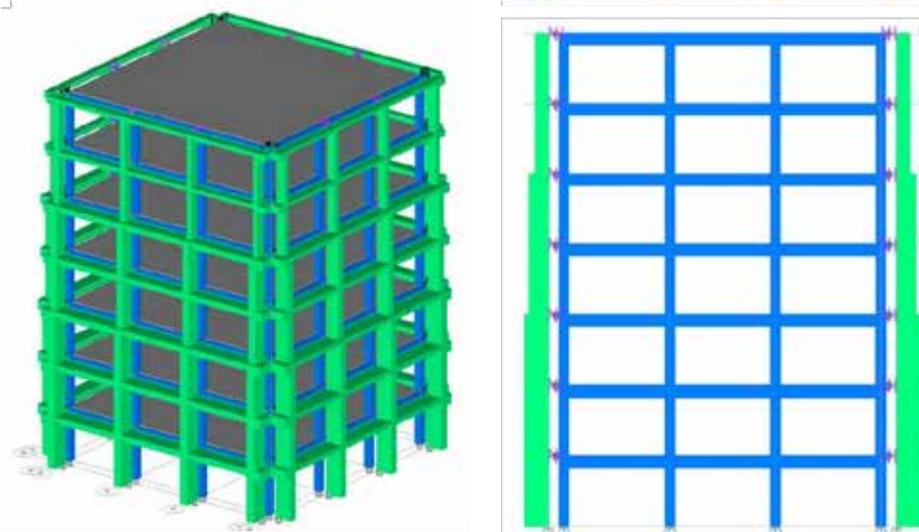
Figure 9. 3D view and section of the retrofitted 7-story building by encasement technique

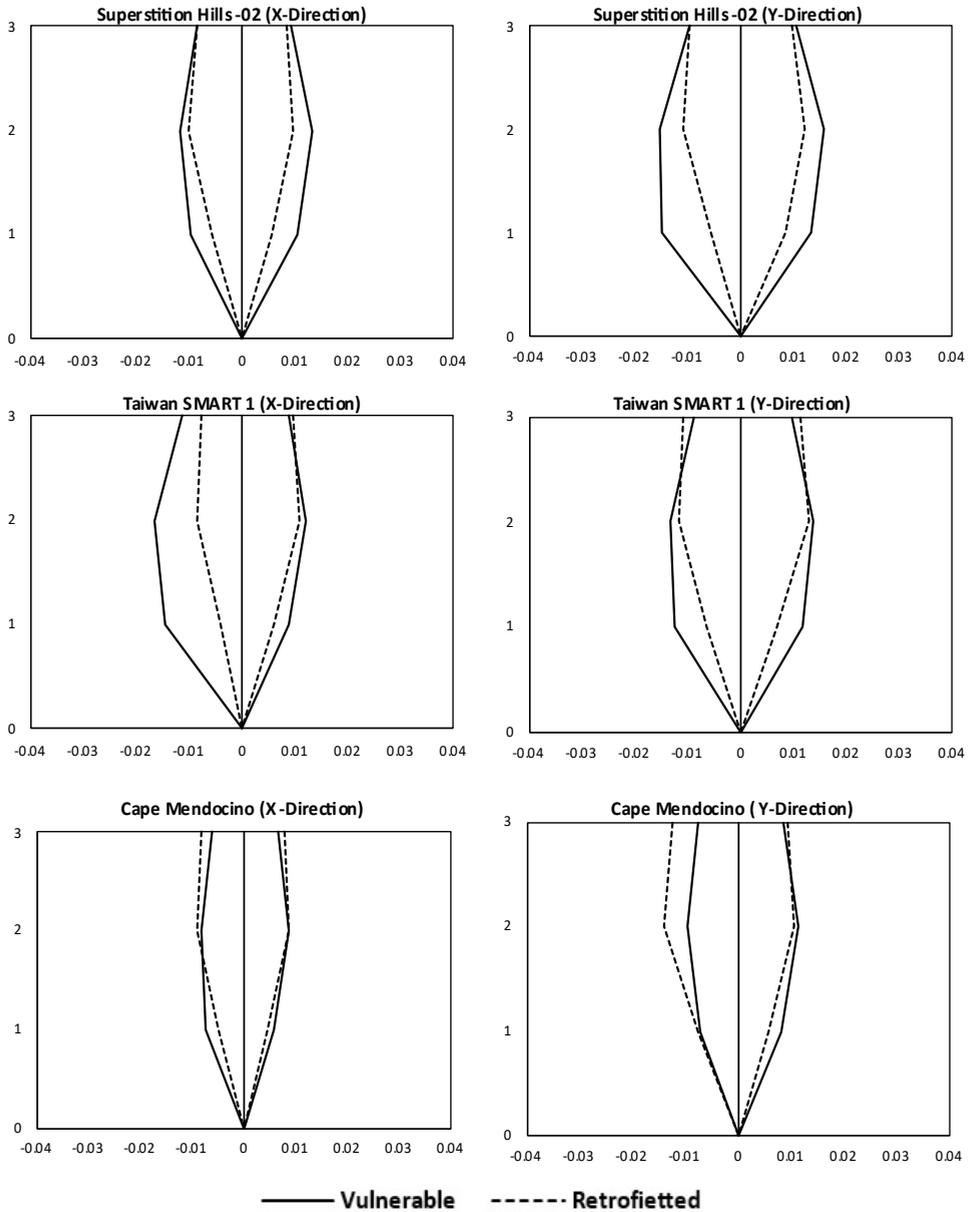
Figure 11. Inter-story drift ratios of the 3-story buildings in X and Y directions, subjected to three of the seven elected earthquakes

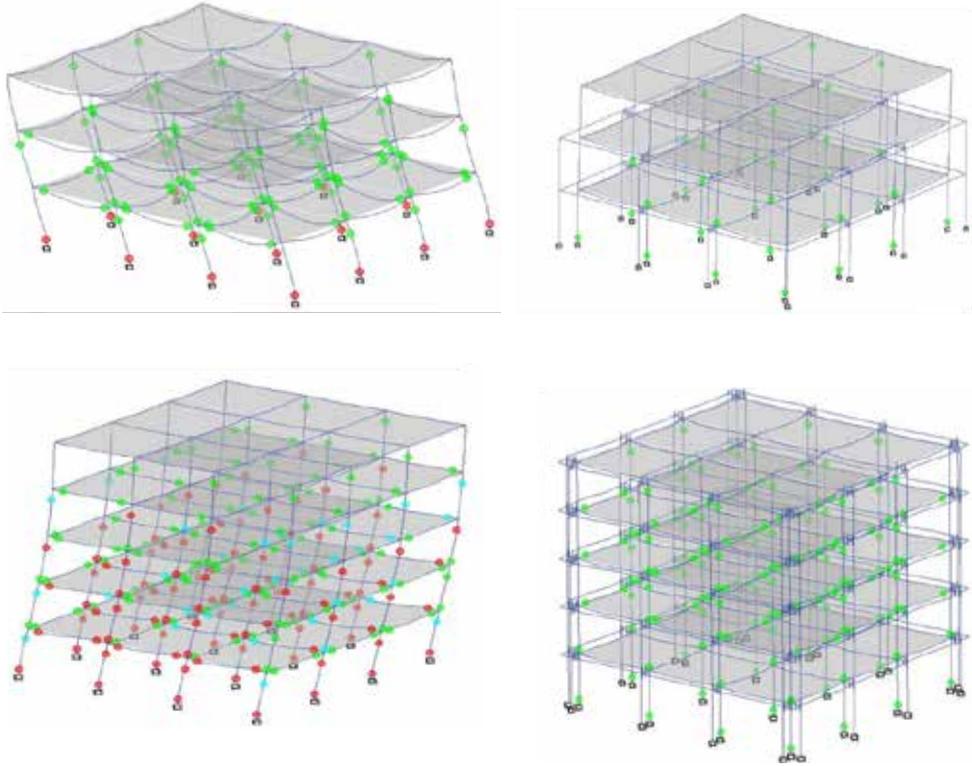
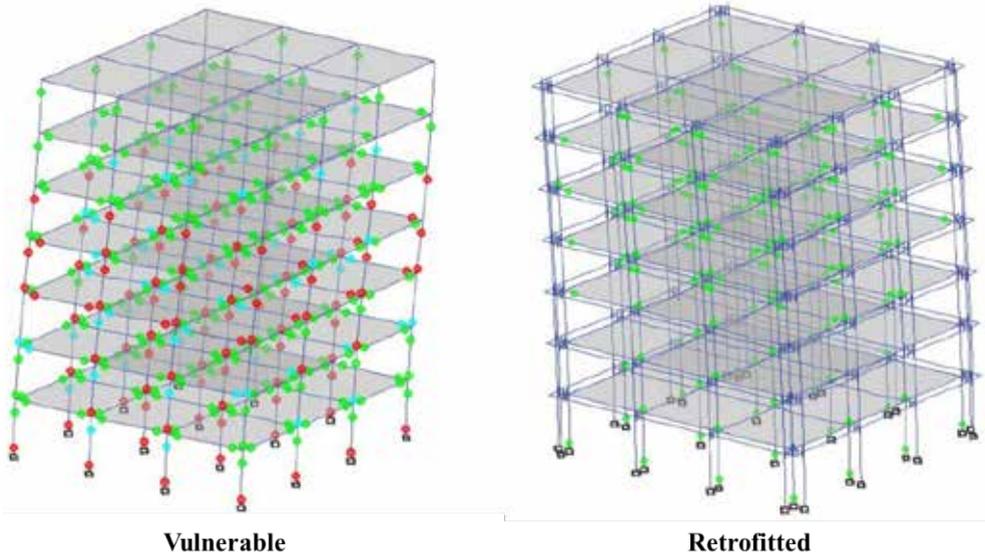
Figure 12. PHs formed in the buildings' structures at the end of Superstition Hills 02 earthquake record

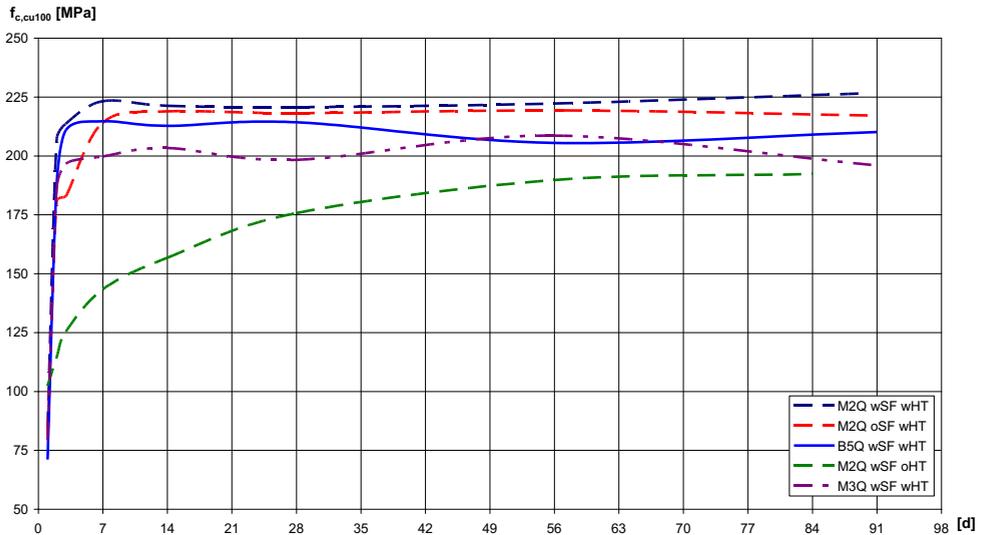
Fig. 1: Strength development of UHPC (mixture M2Q, M3Q and B5Q)

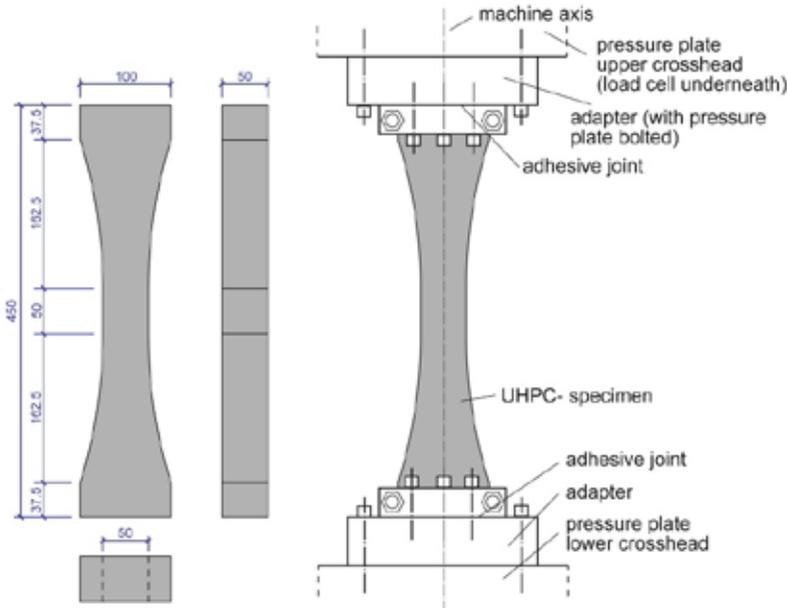
Fig. 2: Dimensions of bone-shaped UHPC-specimens [mm] and test arrangement

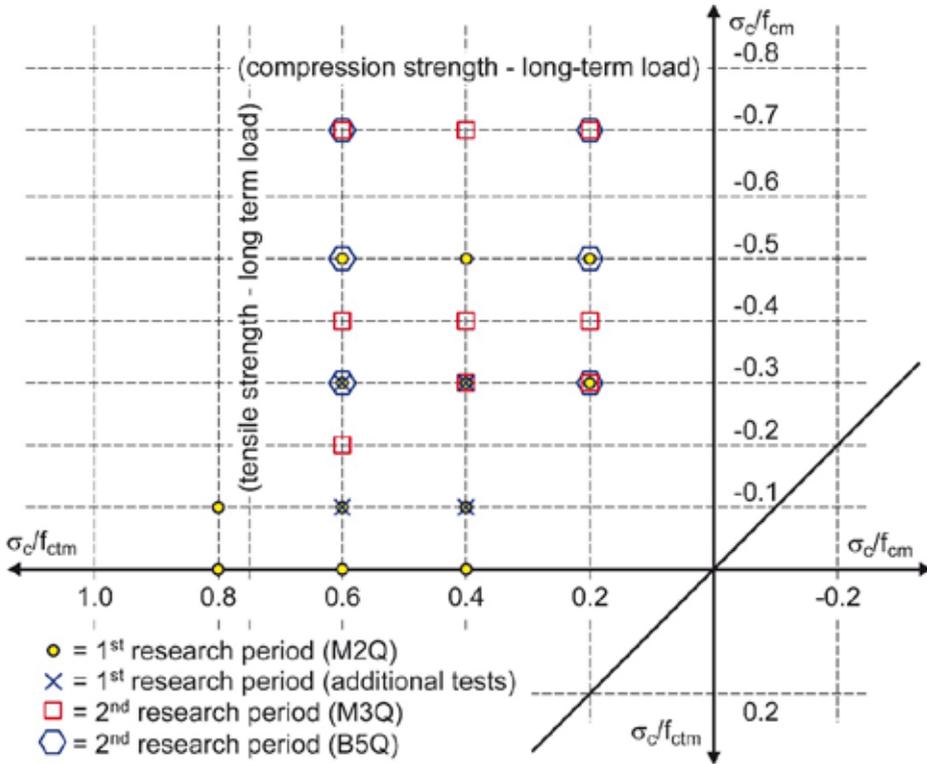
Fig. 3: Goodman diagram, researched combinations marked (M2Q, M3Q and B5Q)

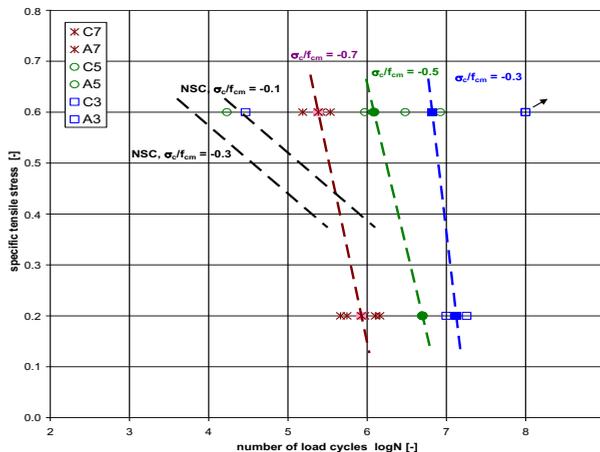
Fig. 4: S-N-curves of UHPC (B5Q) wSF wHT (M-B.F.T.H.)

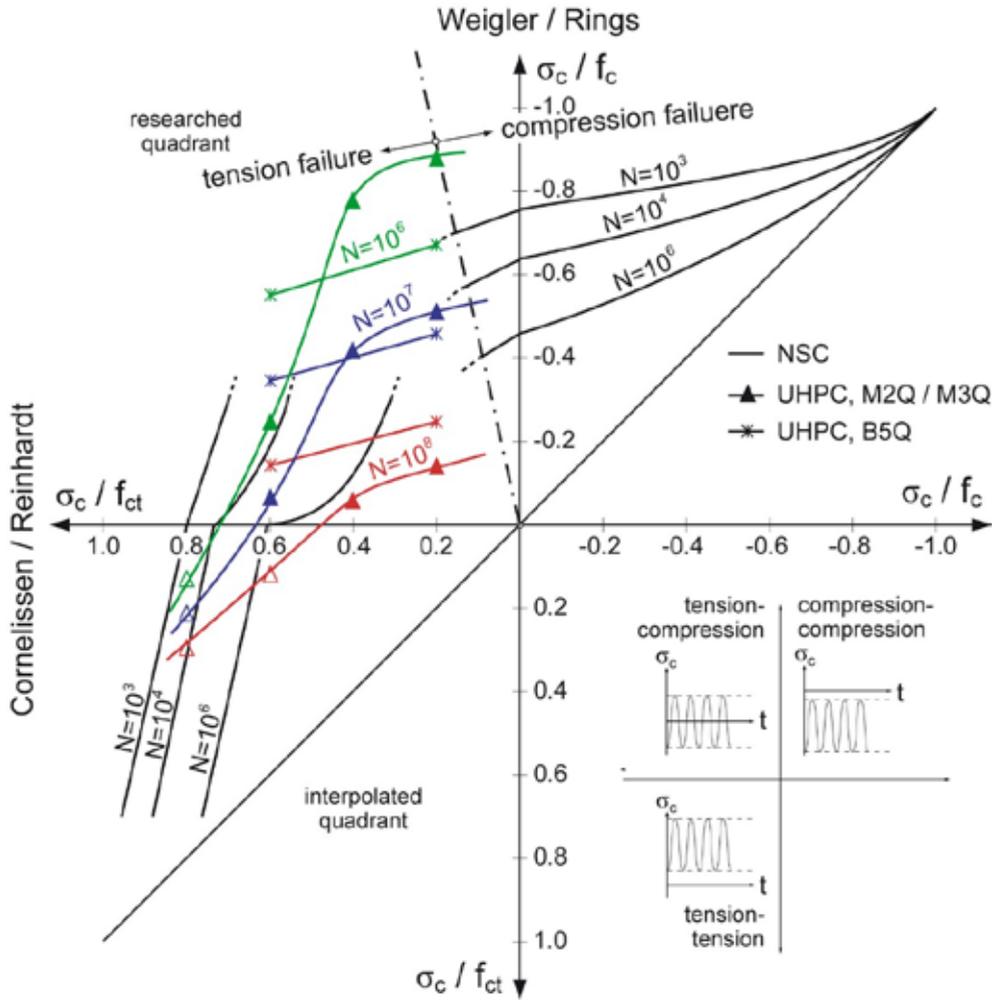
Fig. 5: Goodman diagram for NSC and UHPC under cyclic loading

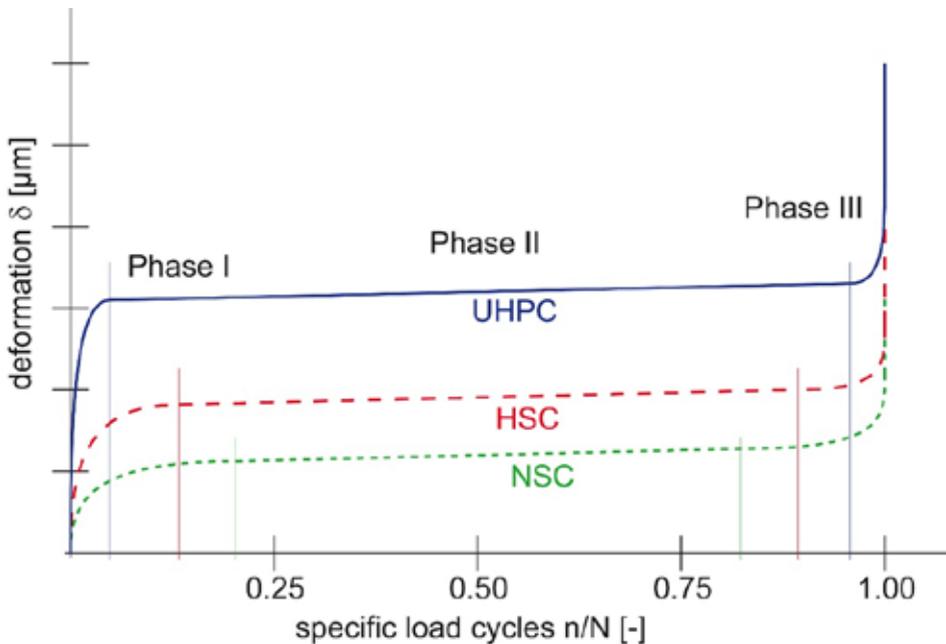
Fig. 6: Damage progress for single-level fatigue tests (model)

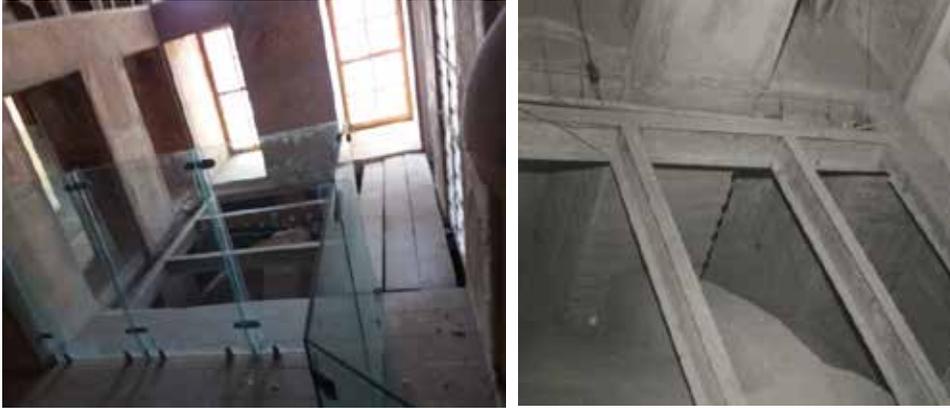
Figure 2. Ali Qapu building, lightening the roofs at sixth floor, 1965-1970.

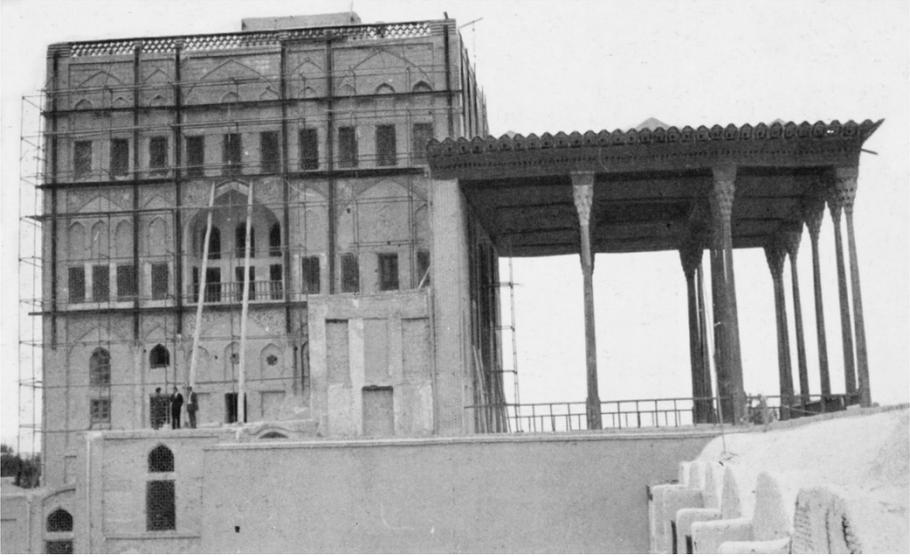
Figure 4. Ali Qapu building, using horizontal circumferential frame in the whole building in order to prevent the external parts from detaching, 1964-1970 (after Galdieri [5]).

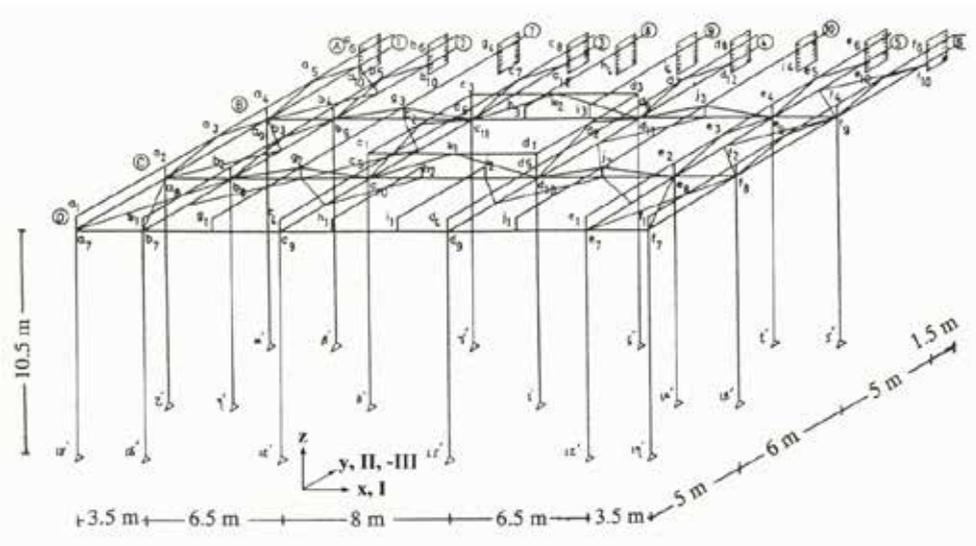
Figure 5. Ali Qapu building, the wooden columnar structure (after Hejazi [2, 6]).

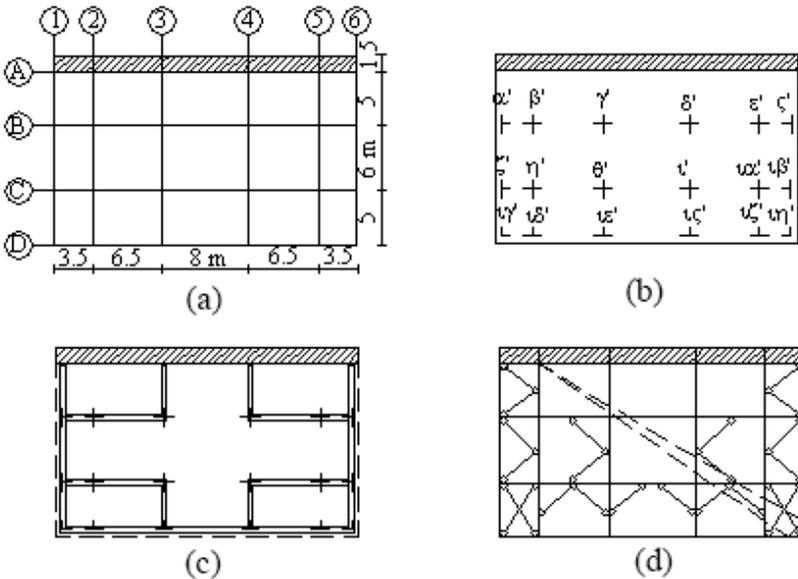
Figure 6. Ali Qapu building, wooden columnar structure: a) horizontal plan of the frames, b) horizontal plan of the columns, c) horizontal plan of the wooden spreaders under the columns, d) existing lateral bracing system before 2000 (after Hejazi [2, 6]).
