PROCEEDINGS OF INTERNATIONAL CONFERENCE ON ISTANBUL AND EARTHQUAKE 2022

Organized by IAU Disaster Training Application and Research Center (AFAM)

**PROCEEDINGS OF INTERNATIONAL CONFERENCE
ON ISTANBUL AND EARTHQUAKE 2022**

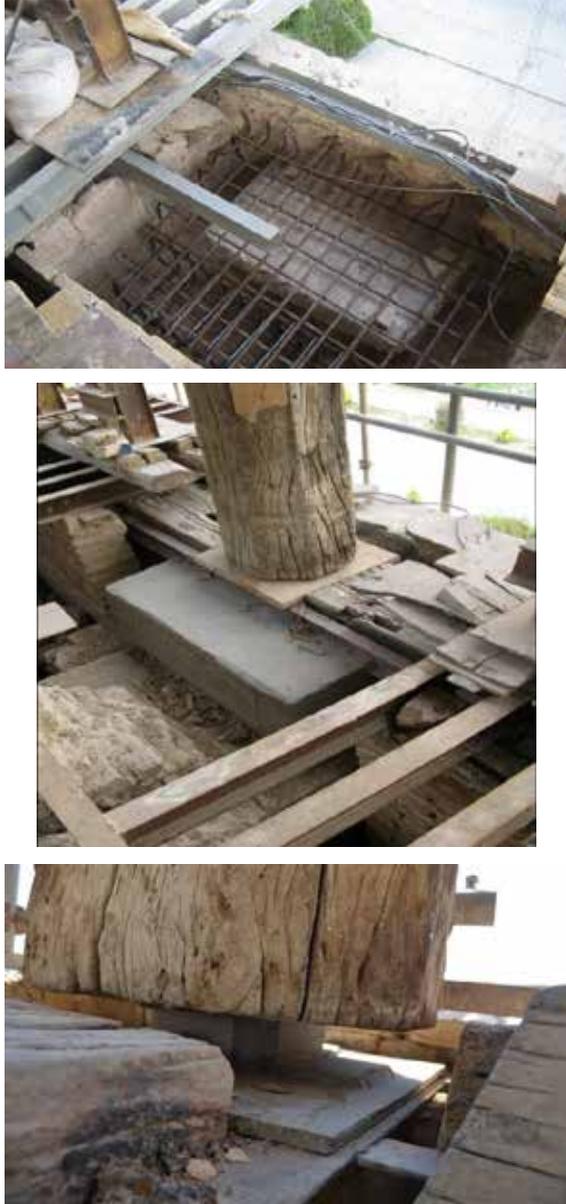
Figure 10. Ali Qapu building, strengthening the supports of the columns (2005 to 2017).

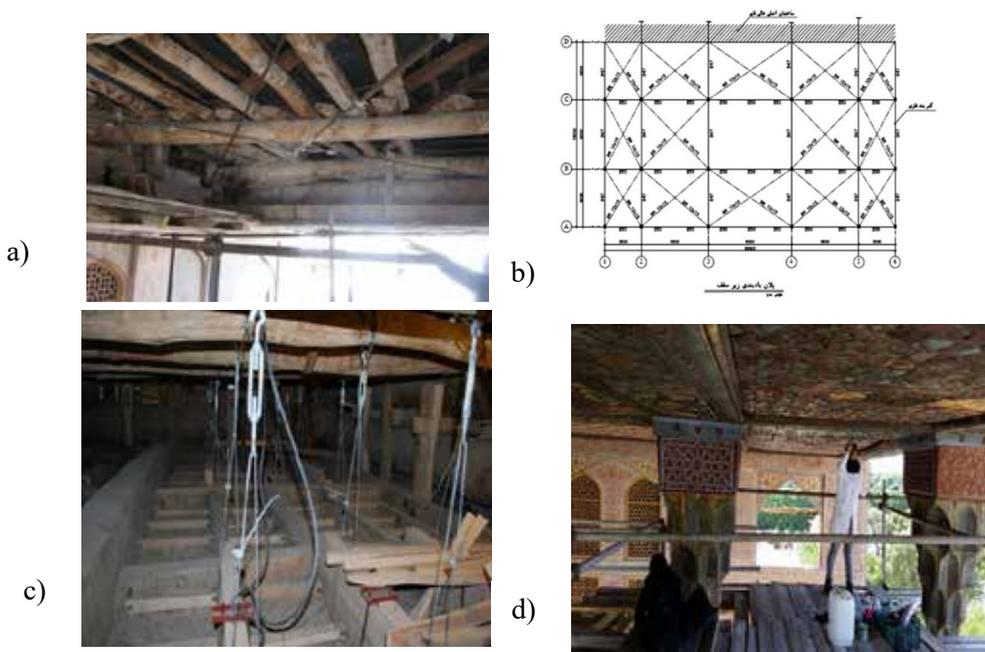
Figure 12. Ali Qapu building, the roof of the wooden columnar structure: a) and b) adding steel cables as the lateral load bearing system, c) and d) supporting the hanging ceiling by steel hangers (2005 to 2017).

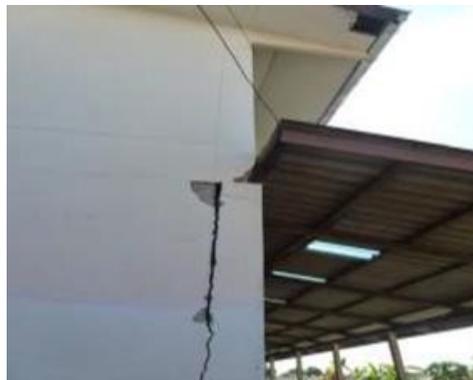
Figure 1. School buildings : Observed damage on buildings in Thailand by Mae Lao earthquake

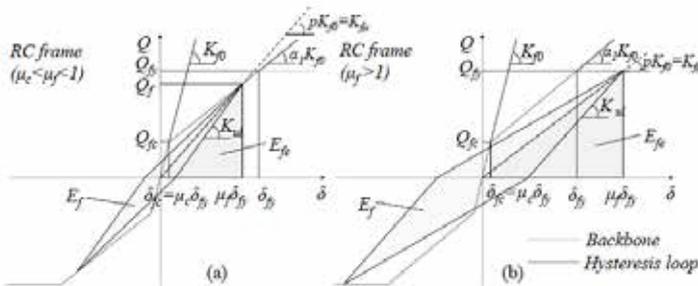
Figure 2. Hysteresis loops for RC frame : (a) Cracked ($\mu_c \mu_f > 1$, $\mu_f < 1$), (b) Yielding ($\mu_f > 1$)

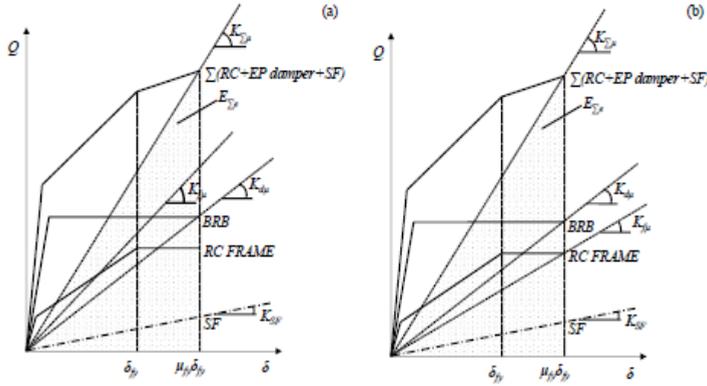
Figure 5. Overall behavior of system model : (a) Cracked ($\mu_c\mu_f > 1$, $\mu_f < 1$), (b) Yielding ($\mu_f > 1$)

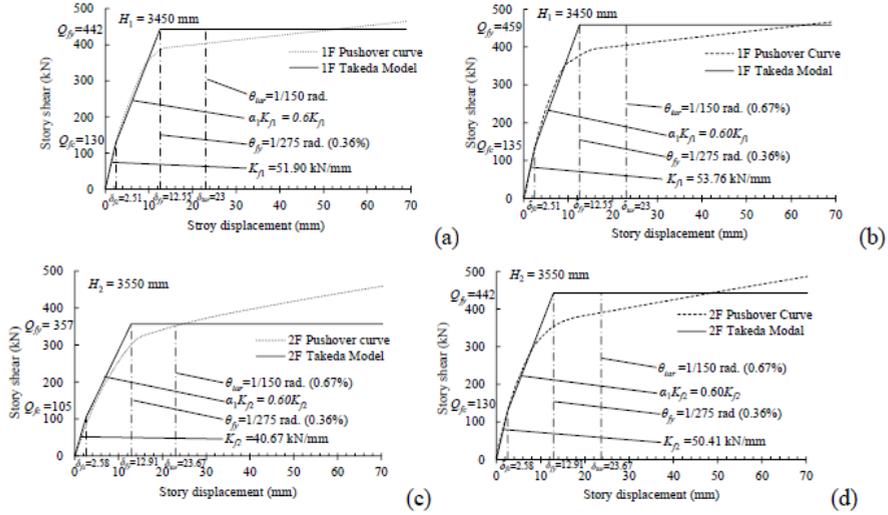
Figure 6. Pushover curve and tri-linear model of 2-story building : (a) Longitudinal direction for first story, (b) Transverse direction for first story, (c) Longitudinal direction for second story, (d) Transverse direction for second story

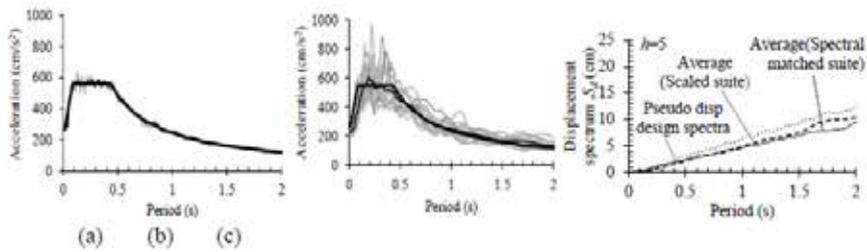
Figure 7.5% damped response spectra : (a) Matched suite, (b) Scaled suite and (c) Displacement spectra

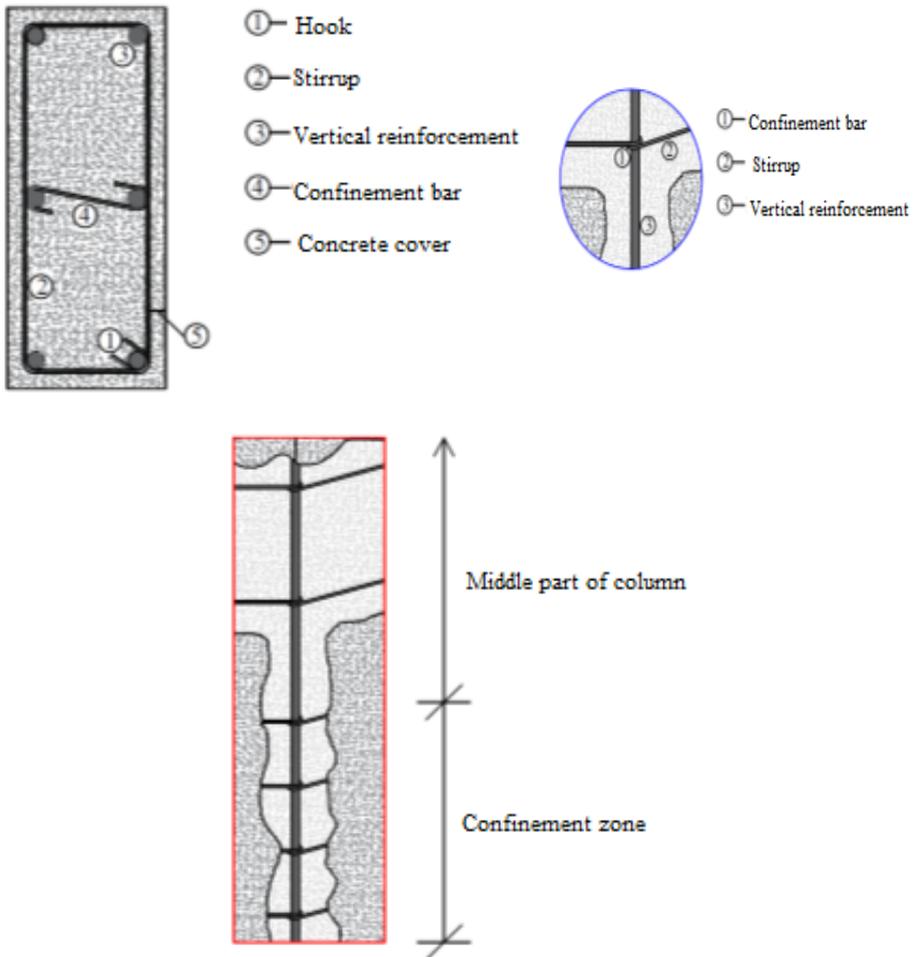
Figure 3. Longitudinal and transverse reinforcement determinations by stripping method in columns (RYTEIE-2019)

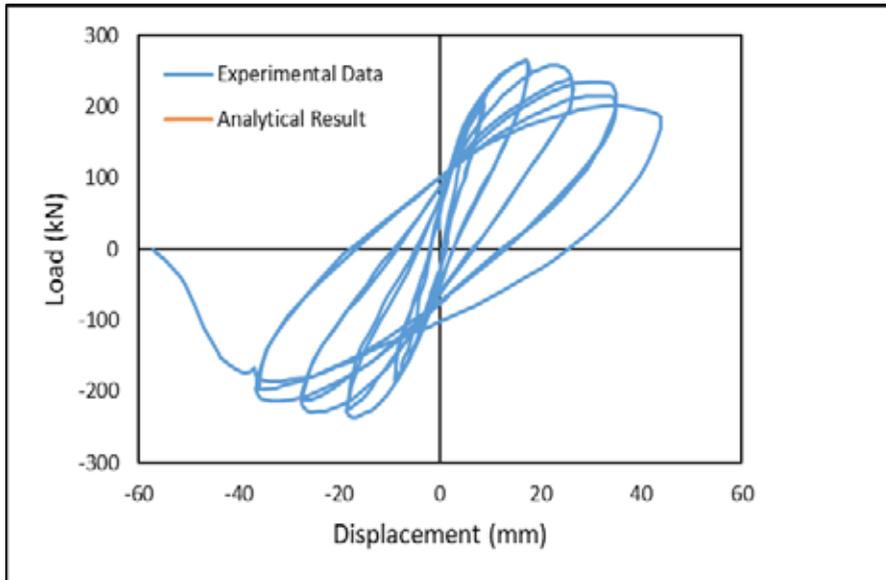
Figure 1. Soesianawati Experimental Study (Soesianawati et al. 1986, No. 4).

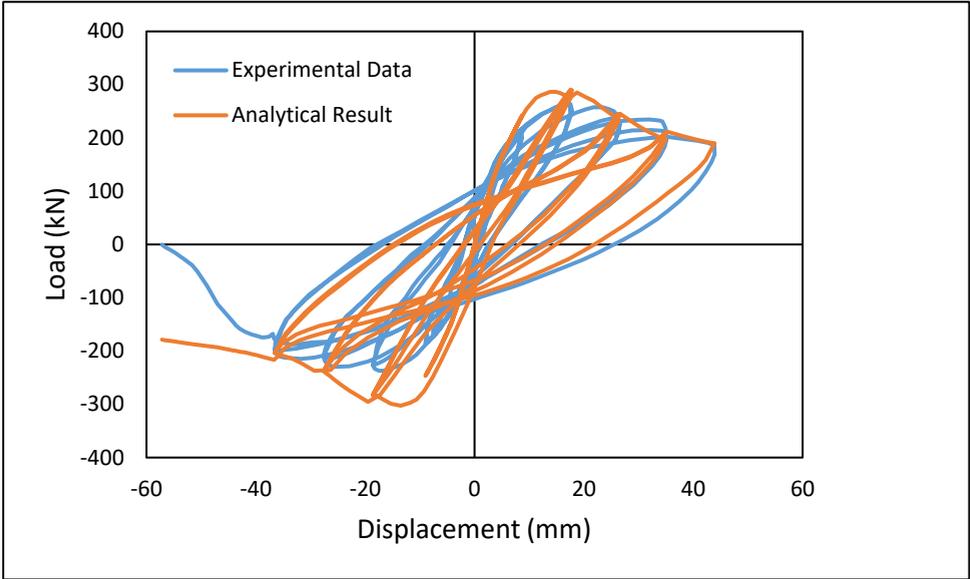
Figure 5. Trilinear Concrete -Menegotto Pinto Steel Model – M04

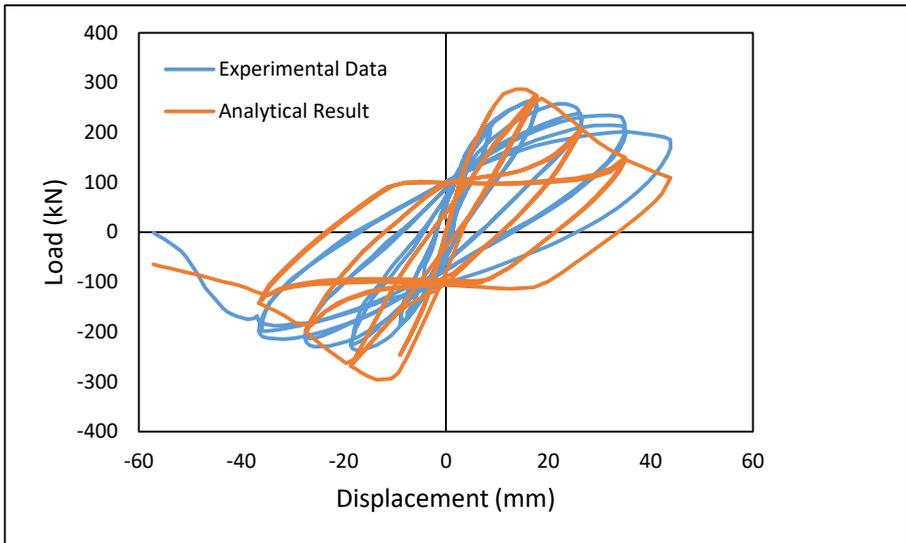
Figure 6. Trilinear Concrete - Bilinear Steel Model – M05

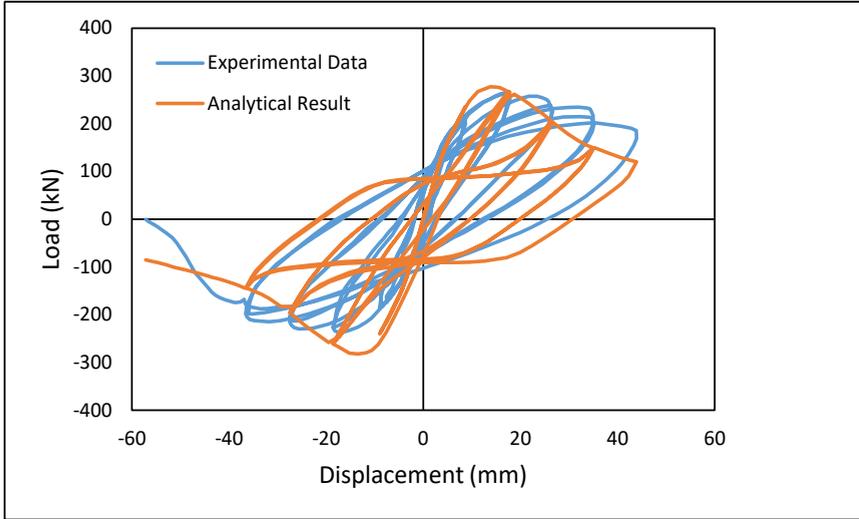
Figure 7. Trilinear Concrete – Ramberg Osgood Steel Model – M06

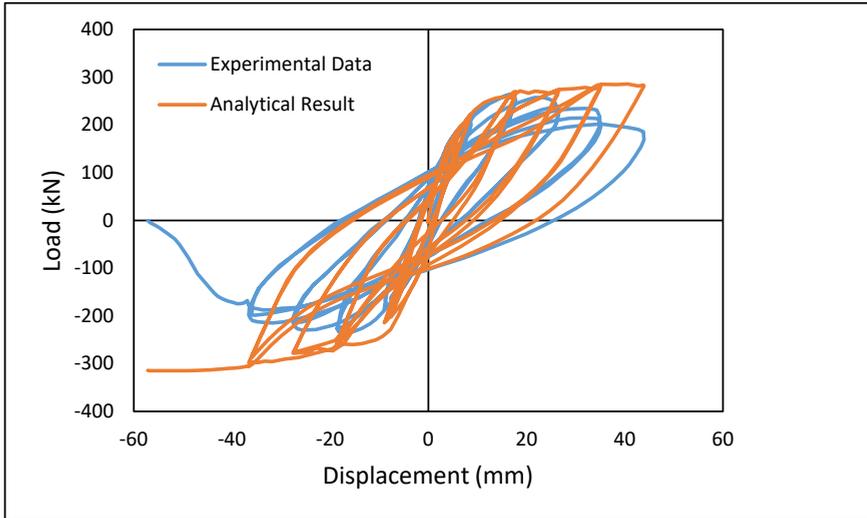
Figure 8. Chang and Mander Concrete -Menegotto Pinto Steel Model – M07

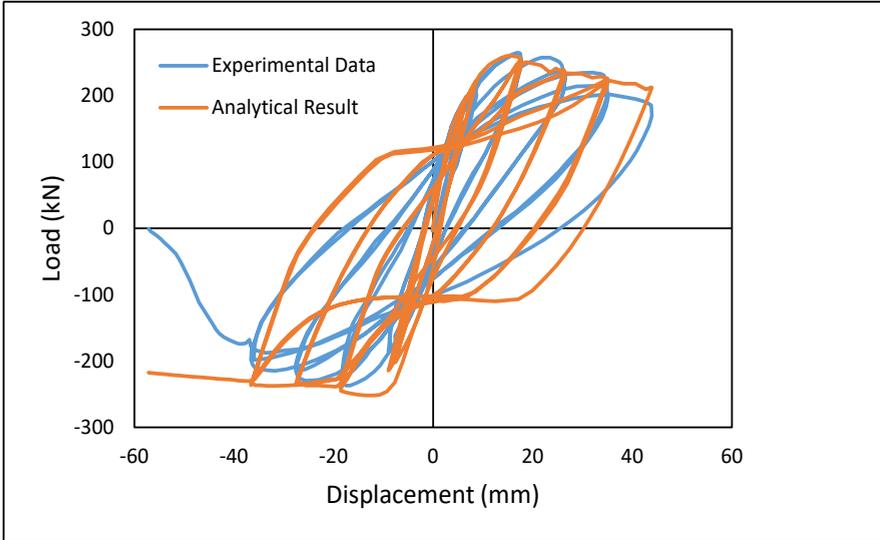
Figure 9. Chang and Mander Concrete - Bilinear Steel Model – M08

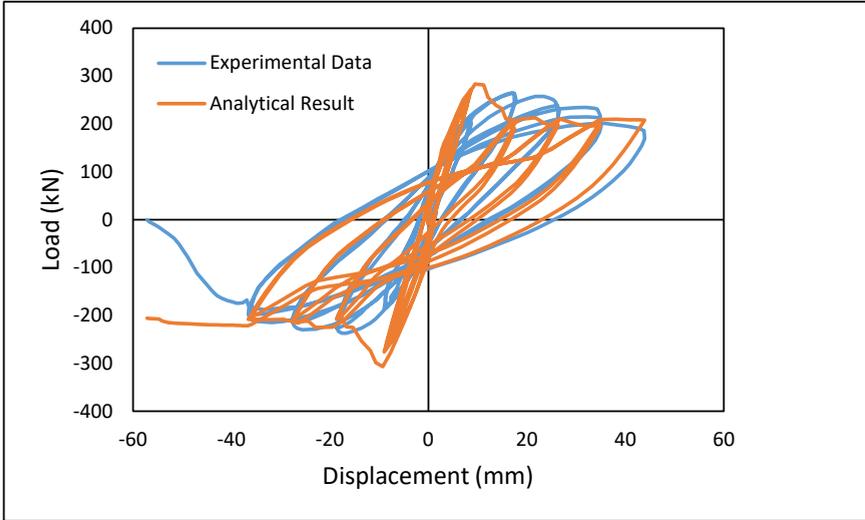
Figure 11. Kappos ve Konstantinidis Concrete -Menegotto Pinto Steel Model -M10

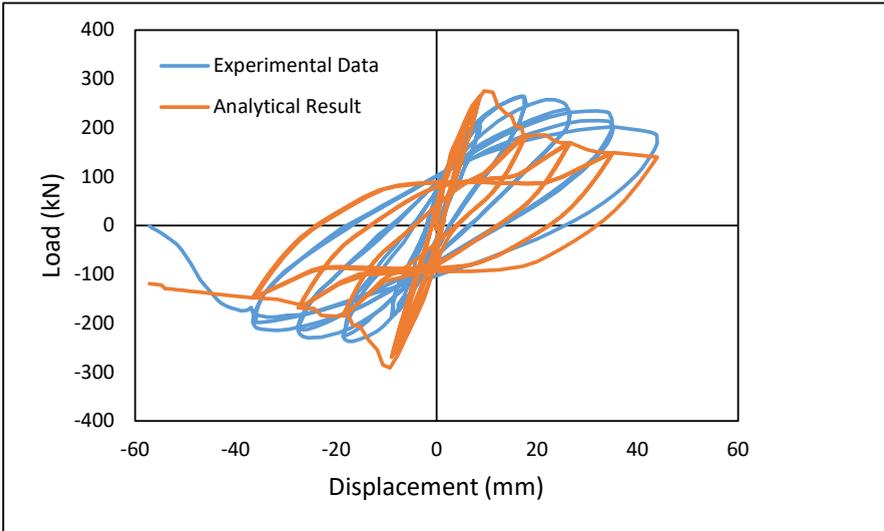
Figure 13. Kappos ve Konstantinidis Concrete – Ramberg Osgood Steel Model – M12

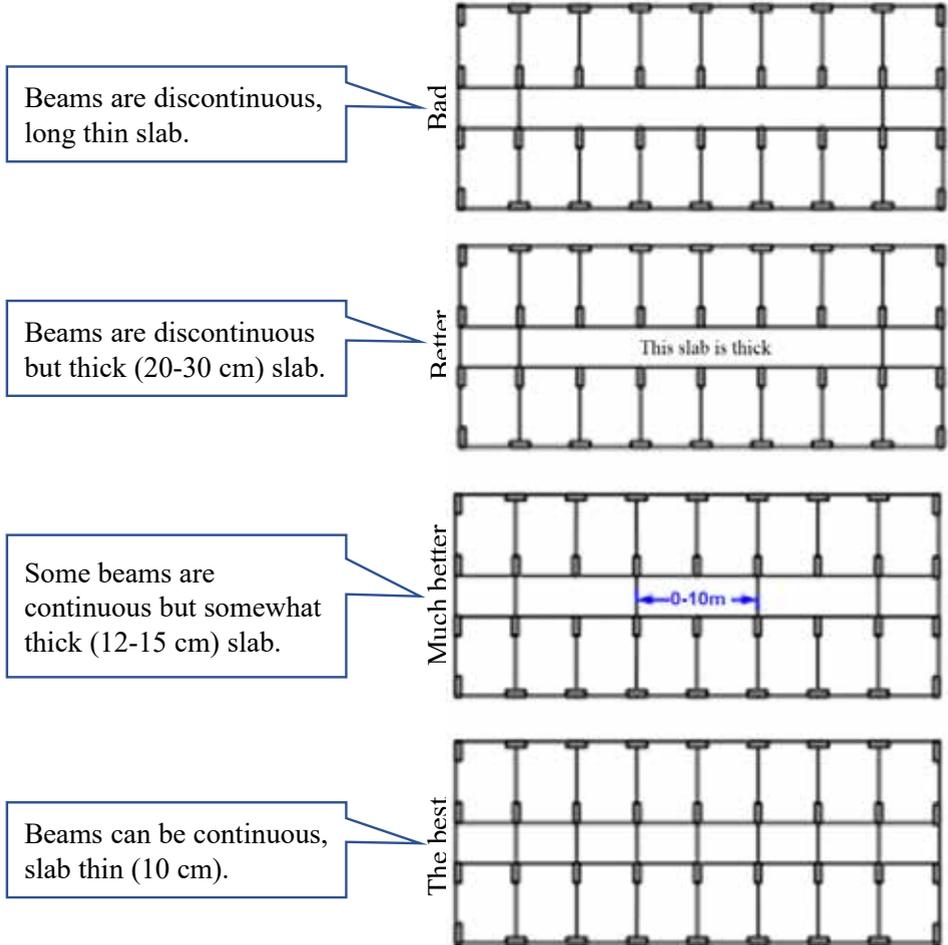
Figure 2. Continuity Recommendations in Beam [1]

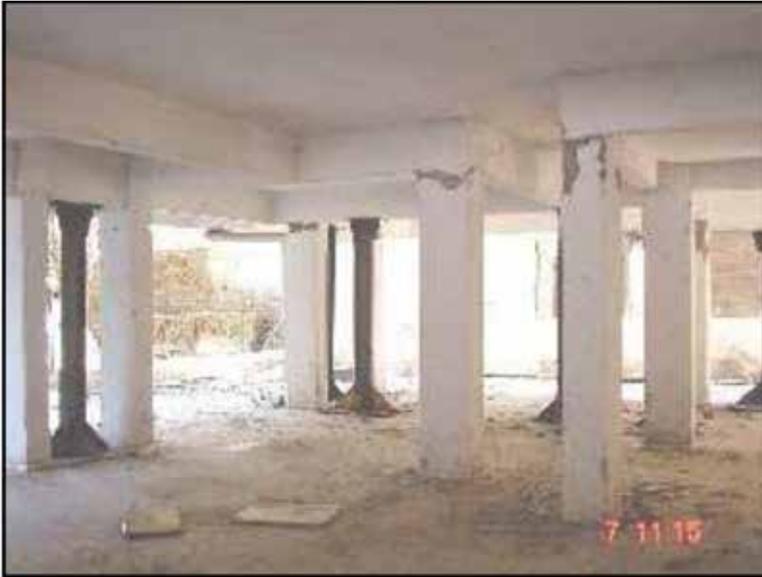
Figure 3. Columns damaged by the effect of discontinuous beams [1]

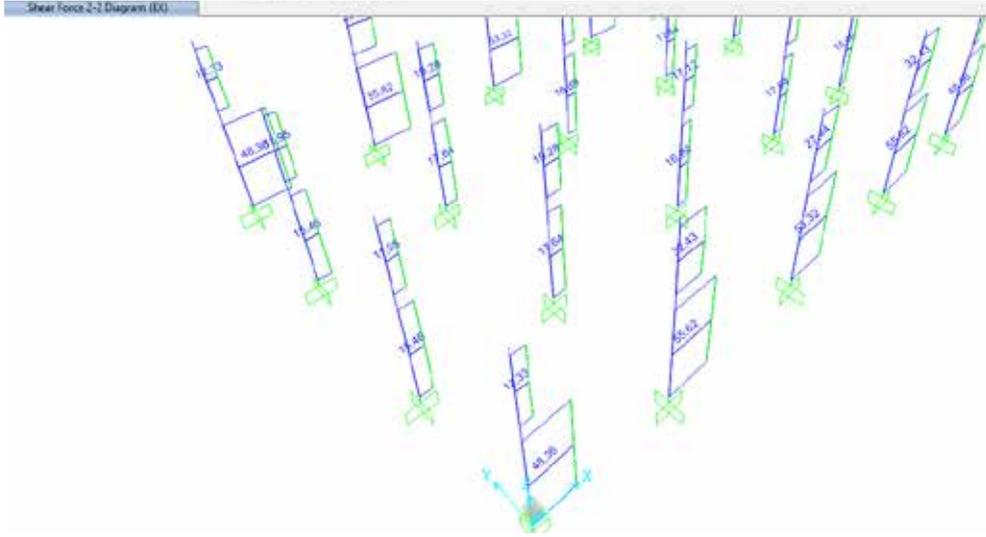
Figure 6. Continuous System Column Shear Forces

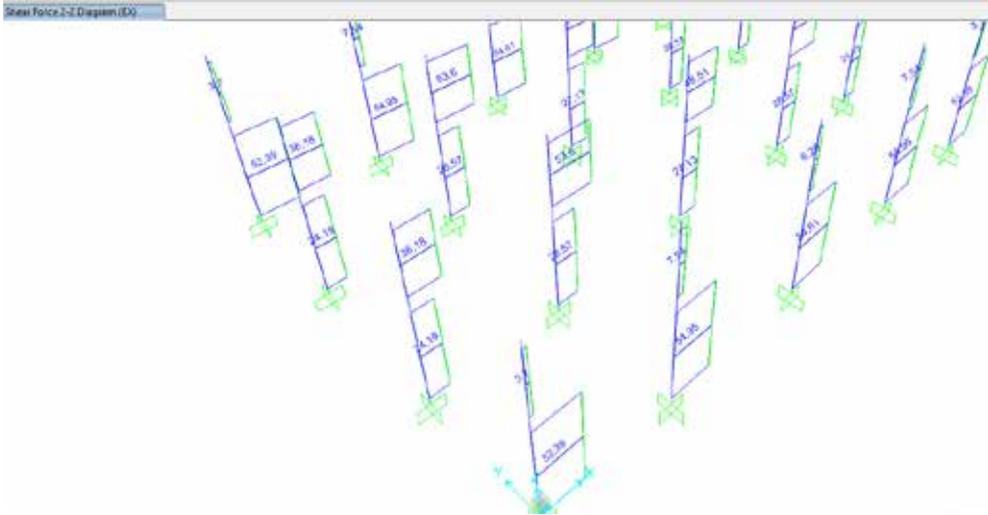
Figure 8. System Column Shear Forces with Alpha Value of 0.5

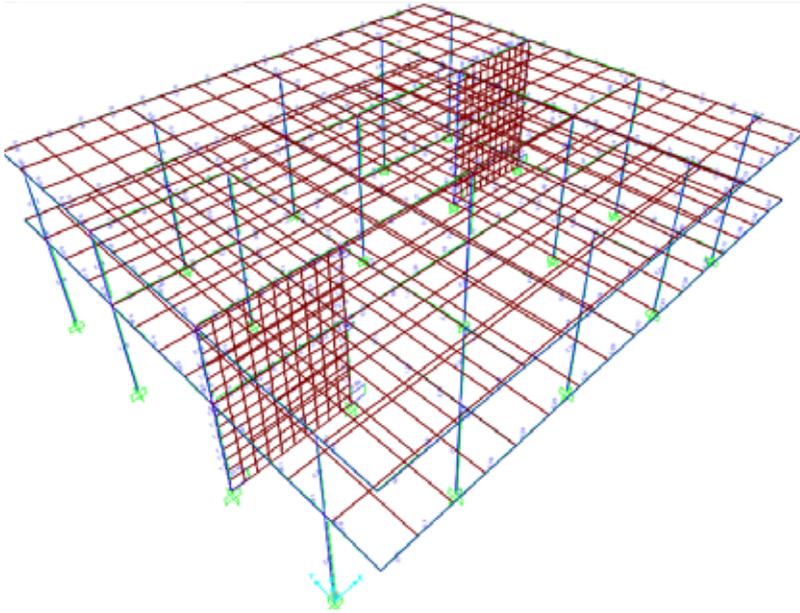
Figure 11. The shear forces formed in the structure by placing a shear wall have decreased excessively.
